EVALUATION REPORT 8-65

EVALUATION OF THE LINDE FLOW WARNING DEVICE

BUREAU OF SHIPS
PROJECT F011-06-03 TASK 3380

30 DECEMBER 1965

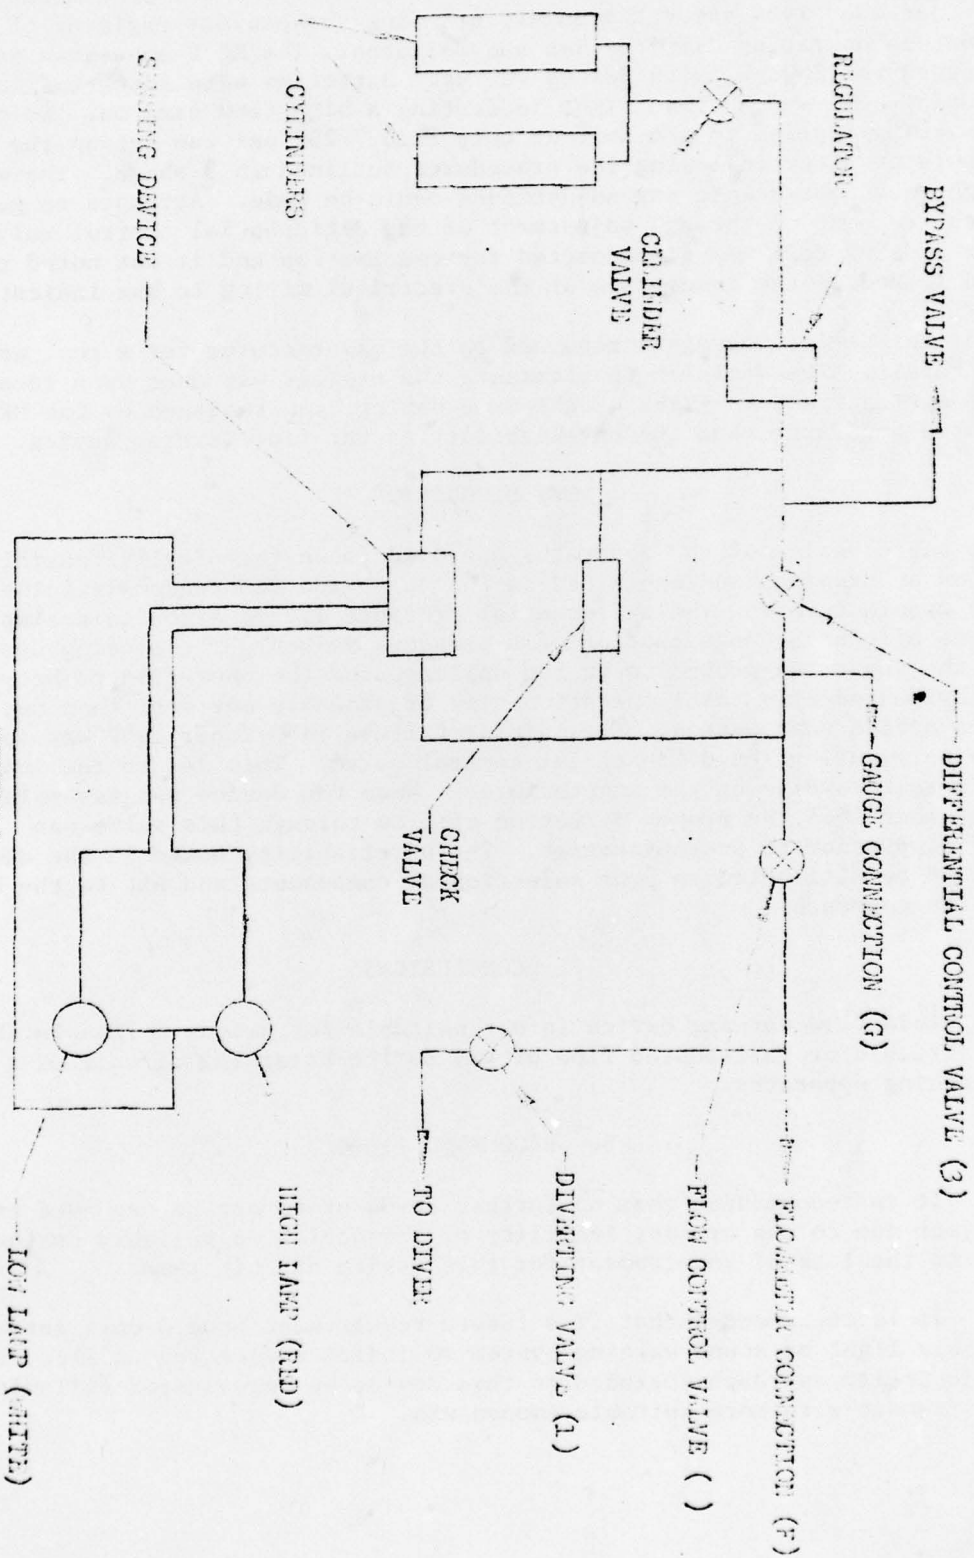
FIGURE 1.
SCHEMATIC DIAGRAM : REGULATOR & WARNING DEVICE

2.1 The warning device is schematically illustrated in figure 1. Photographs are provided in figures 2, 3, 4 and 5. The flow warning device consists of a differential control valve, a flow control valve, a check valve, an aneroid sensing device, a battery pack and red and white warning lights.

5.2 The warning device was returned to the Linde Co. for inspection and repair. It was found that the aneroid had been collapsed due to the shutting of the adjusting valve and resultant increased pressure differential. The aneroid was replaced and the check valve shown in figure one was placed in the circuitry. This valve was designed to open when the pressure differential reached 28-30 psi, to prevent damage to the aneroid due to closing of the differential control valve.
